**EVALUATION OF FORGED HELICOPTER COMPONENTS  
PROCESSED WITH CONTROLLED SOLIDIFICATION AND  
THERMAL-MECHANICAL TREATMENTS**

William L. Weiss  
Boeing Vertol Company  
P.O. Box 16858  
Philadelphia, Pennsylvania 19142

Final Report      Contract Number DAAA25-77-C-0015

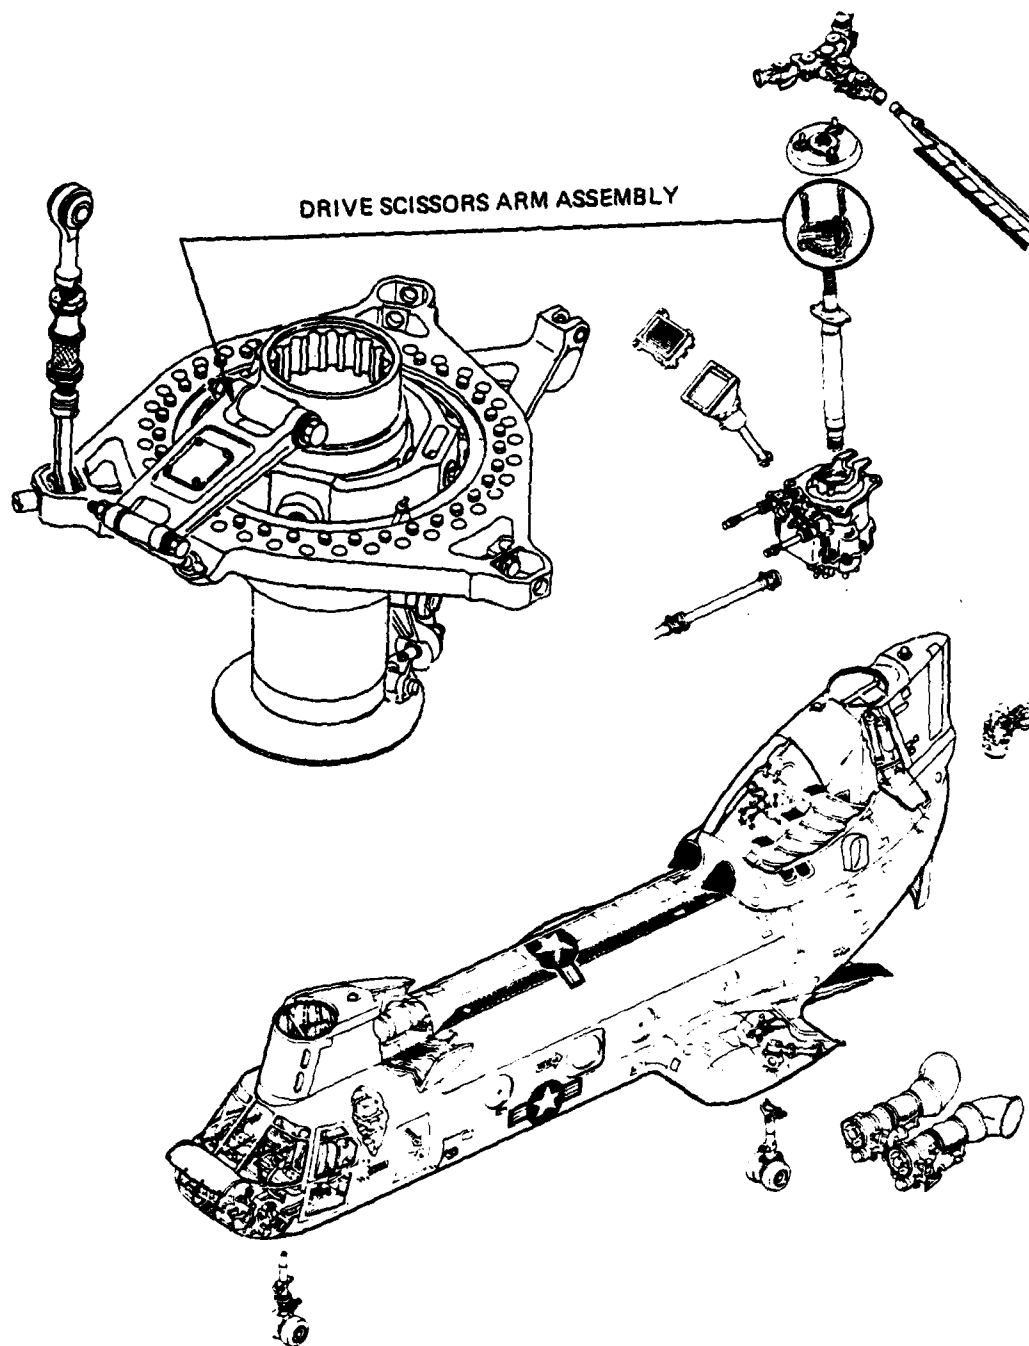
Figure 3. Location of Drive Scissors Arm Assembly With Respect to Helicopter Rotor Control System

Photographs of each of these components are shown in Figures 1 and 2. Both components are located in the helicopter control system. Figures 3 and 4 show the locations of these components with respect to the helicopter rotor control system. These components are considered flight critical since failure of one of these components could possibly lead to loss of the aircraft. The governing mode of loading which controlled the structural design of these components was fatigue. At the time of the writing of this report, these components are fabricated from 2014-T6 aluminum alloy forgings and utilized successfully on the H-46 series helicopters built by the Boeing Vertol Company. The components were selected for evaluation of other alloy/processing combinations for the following reasons.

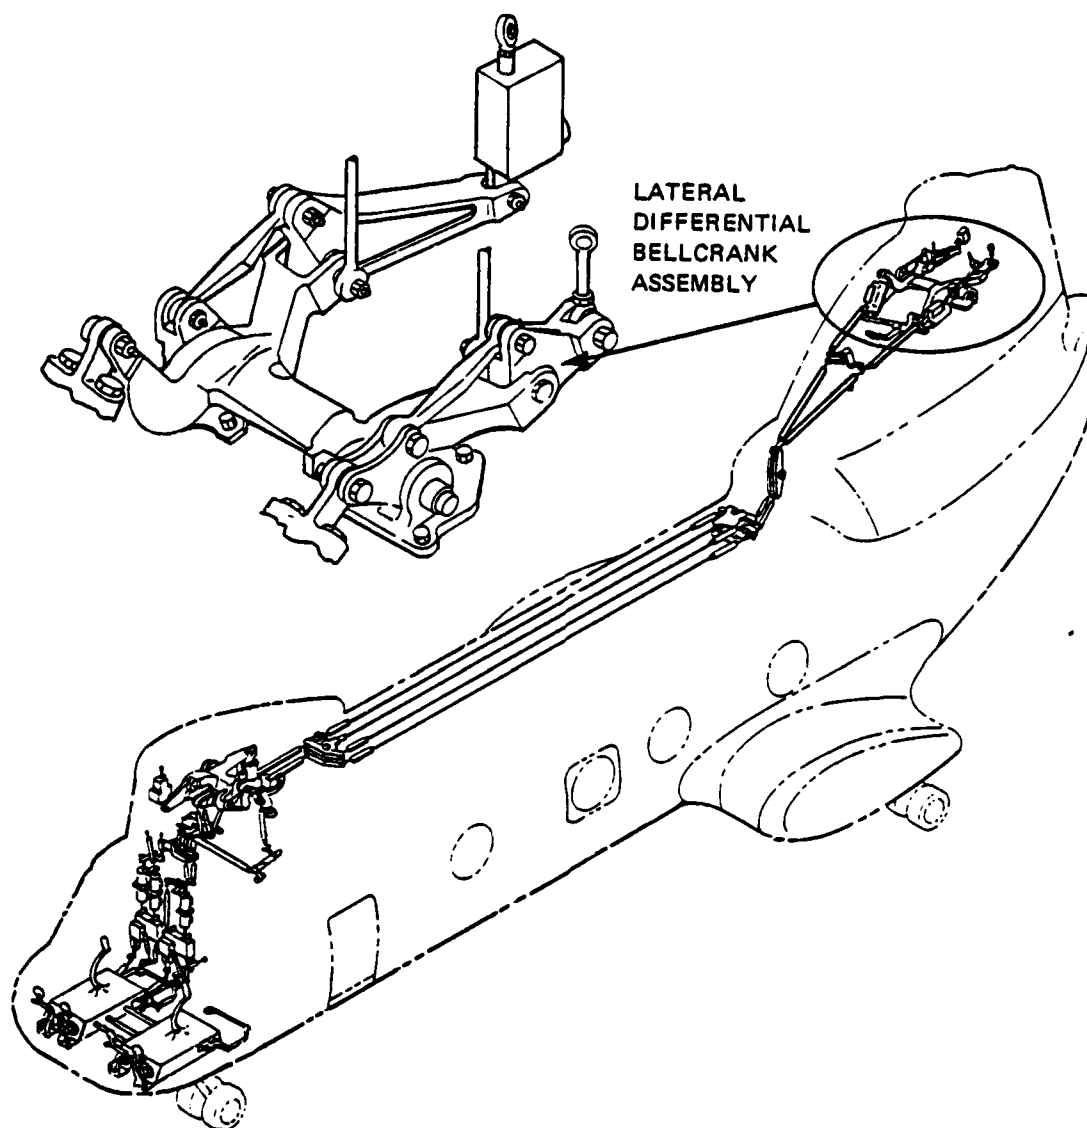
Figure 4. Location of Lateral Differential Bellcrank Assembly with Respect to Helicopter Rotor Control System

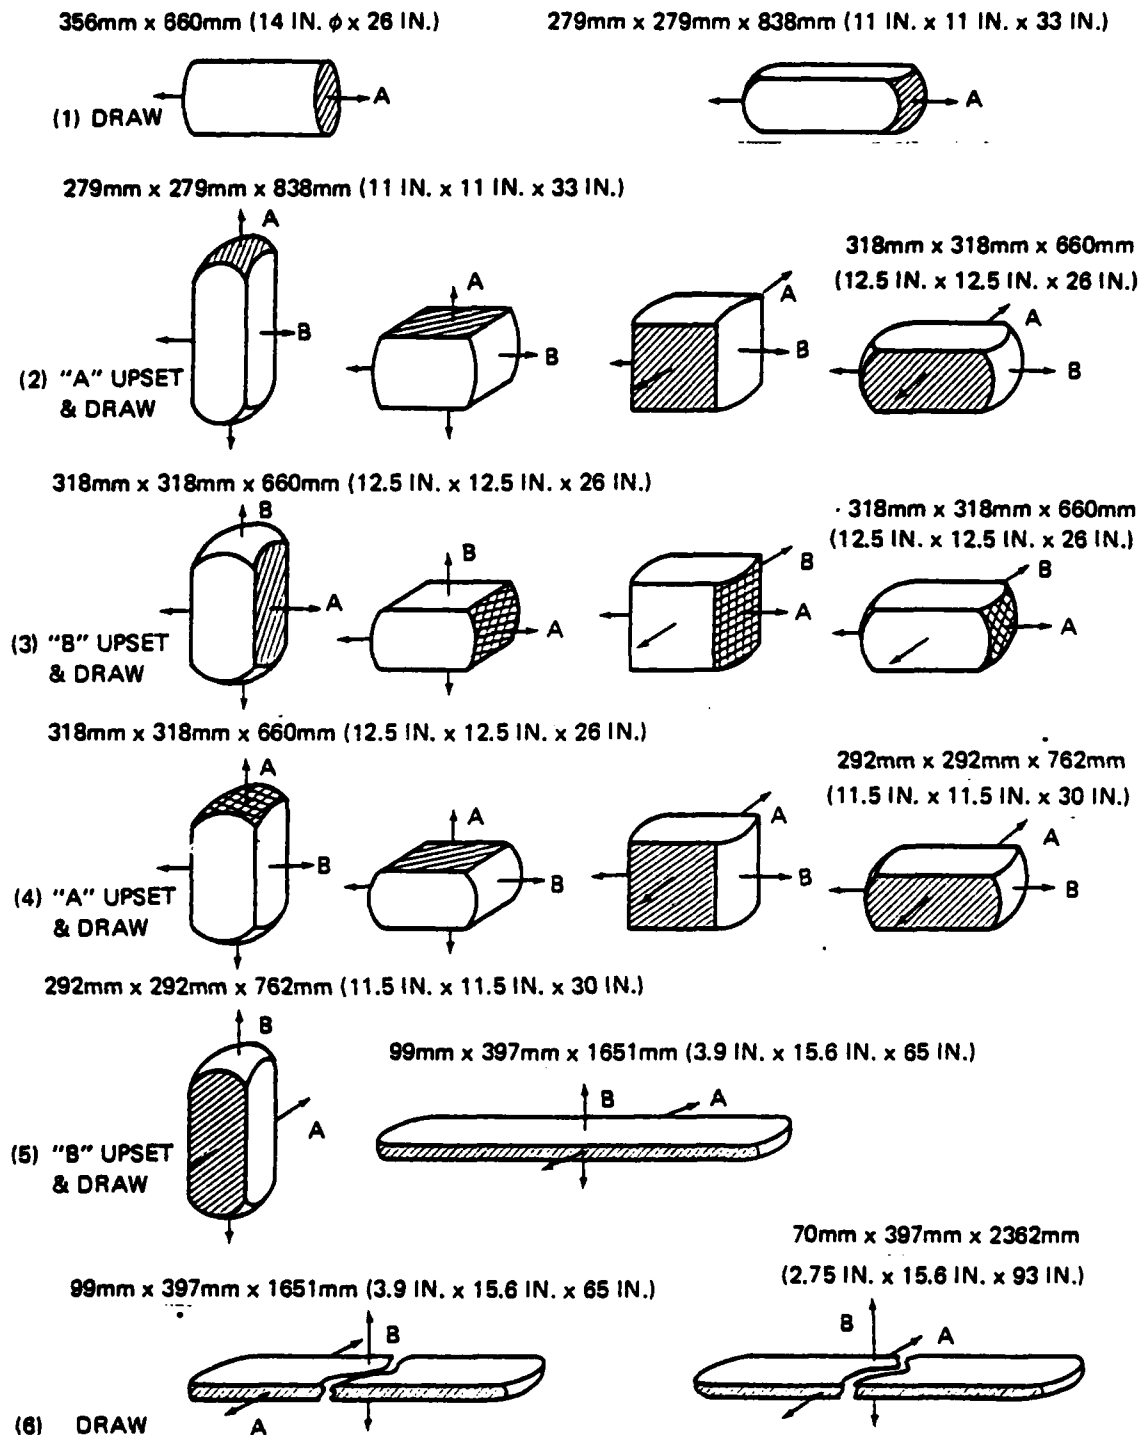
(1) (2) (3)		"A" UPSET AND DRAW TO 318 x 318 x 660MM (12.5 x 12.5 x 26 INCHES) "B" UPSET AND DRAW TO 318 x 318 x 660MM (12.5 x 12.5 x 26 INCHES)
FORGING OPERATIONS	II C	-	ALL	REHEAT TO 413°C (775°F)
	II D	-	ALL	FORGE AT 413°C TO 340°C (775 TO 650°F) "A" UPSET AND DRAW TO 292 x 292 x 762MM (11.5 x 11.5 x 30 INCHES)
	II E	-	7149	ANNEAL 2 HOURS AT 471 TO 460°C (880 TO 860°F), COOL TO 413°C (775°F) 2 HOURS AT 413 TO 401°C (775 TO 755°F), COOL TO 260°C (500°F) 4 HOURS AT 260 TO 249°C (500 TO 480°F)
			7475	2 HOURS AT 516 TO 504°C (960 TO 940°F), COOL TO 413°C (775°F) 2 HOURS AT 413 TO 401°C (775 TO 755°F), COOL TO 260°C (500°F) 4 HOURS AT 260 TO 249°C (500 TO 480°F)
	II F	-	ALL	FORGE AT 230 TO 204°C (450 TO 400°F) "B" UPSET AND DRAW TO 99 x 397 x 1651MM (3.9 x 15.6 x 65 INCHES) NOTE: THE HANDFORGED SLABS OF BOTH ALLOYS INCURRED CONSIDERABLE CRACKING DURING THE 230 TO 204°C FORGING OPERATION. CONSEQUENTLY THE SLABS WERE SONIC INSPECTED AT THIS STAGE AND THE CRACKED AREAS REMOVED BY SAWING BEFORE PROCEEDING WITH FURTHER PROCESSING.

II G	-	7149 7475	RECRYSTALLIZE 10 HOURS AT 460 TO 471°C (860 TO 880°F), AIR COOL 10 HOURS AT 504 TO 516°C (940 TO 960°F), AIR COOL
	II H	-	ALL	FINISH FORGE AT 413 TO 340°C (775 TO 650°F) DRAW TO 70MM (2.75 INCHES) THICK HANDFORGED SLAB
	II I	-	ALL	SAW 24 BLANKS OF EACH ALLOY, SAWED SIZE 70 x 70 x 280MM LONG (2.75 x 2.75 x 11-INCHES LONG)
	II J	-	ALL	MACHINE BLANKS TO 70MM DIAMETER BY 280MM LONG (2.75-INCHES DIAMETER BY 11-INCHES LONG) BILLETS FOR DIE FORGING

Figure 5. Forging Sequences Used to Produce 70mm x 397mm x 2362mm (2.75 IN. x 15.6 IN. x 93 IN.) 7149 and 7475 ITMT Hand Forgings

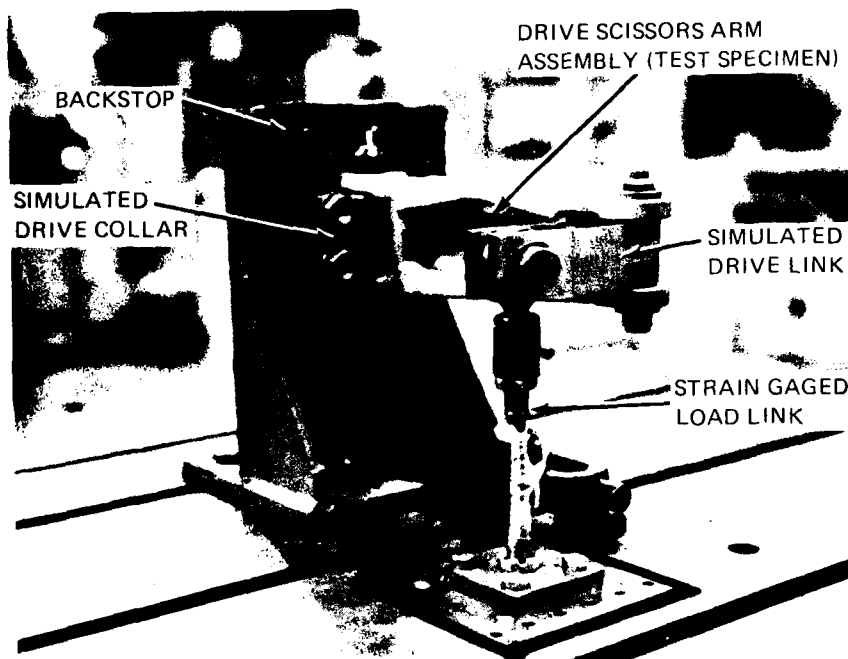
Figure 6. Drive Scissors Arm Assembly, Bench Fatigue Test Setup

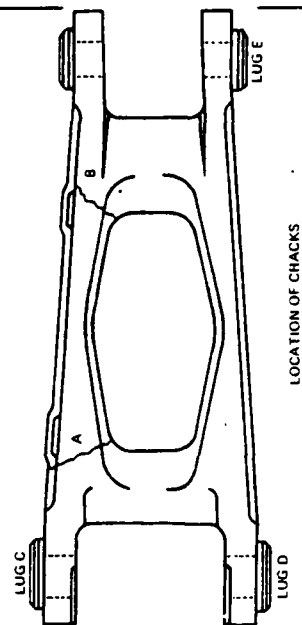
Figure 7. Failure Mode Exhibited by Drive Scissors Arm Assembly, Fatigue Test Specimen Number 4 of 7075-T73 Material

The data resulting from the bench fatigue tests of the drive scissors arm assemblies is summarized in Table 4. Typical modes of failure of these test specimens are shown in Figures 7 through 9.

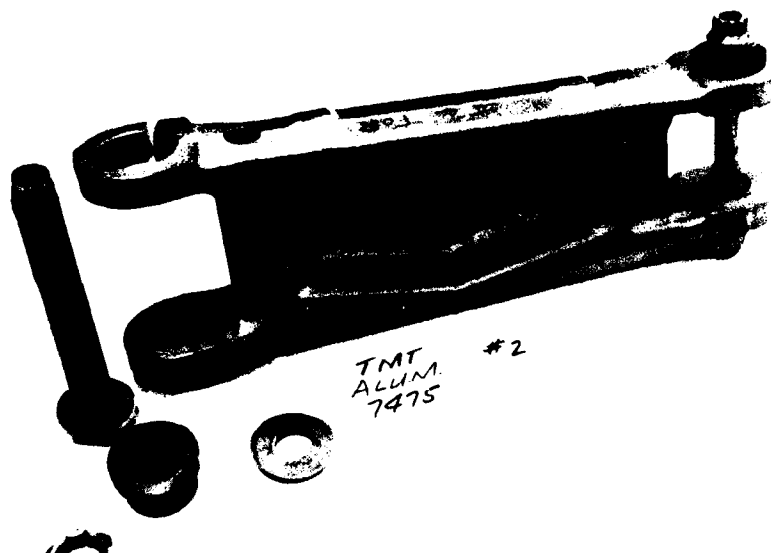
Figure 9. Failure Mode Exhibited by Drive Scissors Arm Assembly, Fatigue Test Specimen Number 2 of 7475-T73 ITMT Material

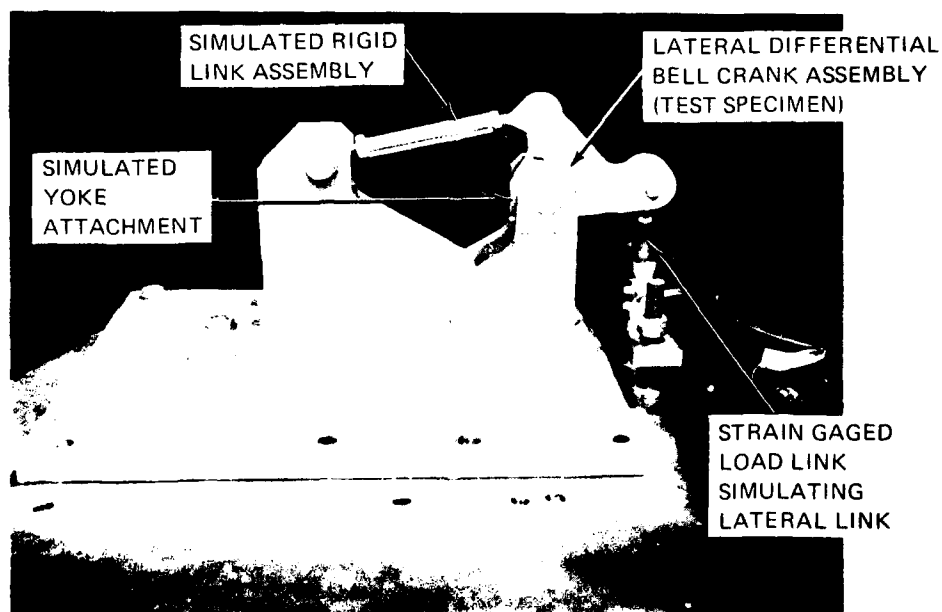
Figure 10. Lateral Differential Bellcrank Assembly, Bench Fatigue Test Setup

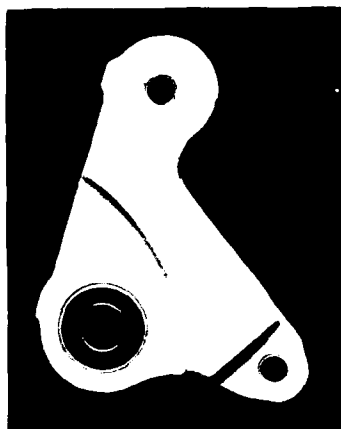
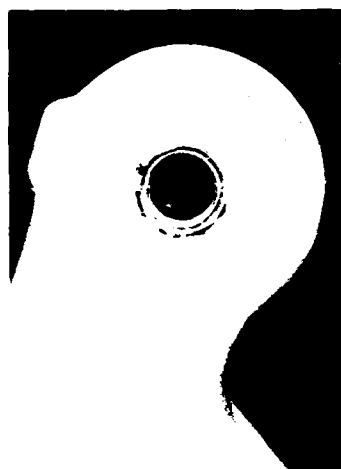
A. OVERALL VIEW OF  
TEST SPECIMEN AFTER  
FATIGUE TESTING

B. CLOSE-UP VIEW OF  
LUG WITH FATIGUE  
CRACK

C. SECTIONAL VIEW OF  
LUG FRACTURE SURFACE

Figure 11. Failure Mode Exhibited by Lateral Differential Bellcrank Assembly, Fatigue Test Specimen Number 1 of 7075-T73 Material

Various modes of failure of these test specimens are shown in Figures 11 through 14. Typically the cracks started at the interface between the aluminum lug bore and the bushing which is installed in the lug bore.

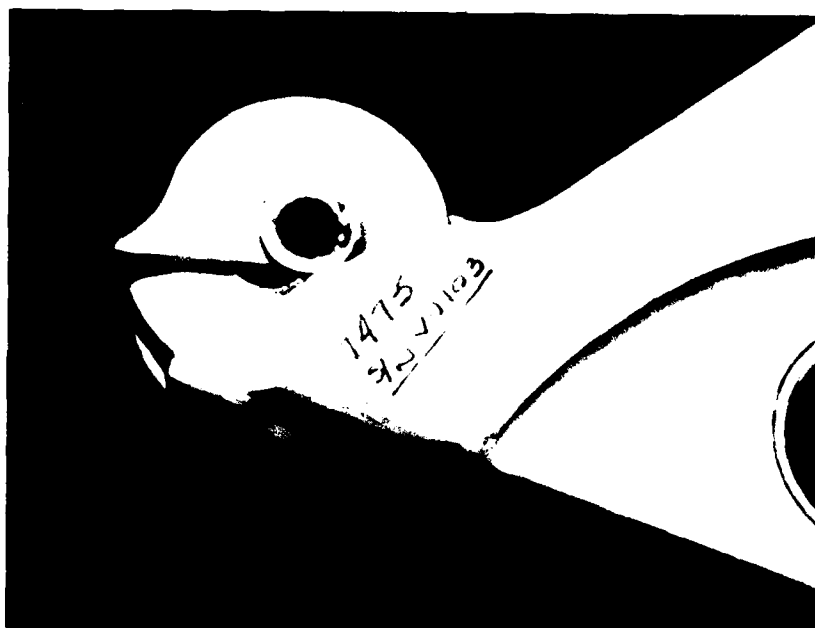
Figure 12. Failure Mode Exhibited by Lateral Differential Bellcrank Assembly, Fatigue Test Specimen Number 1 of 7475-T73 ITMT Material

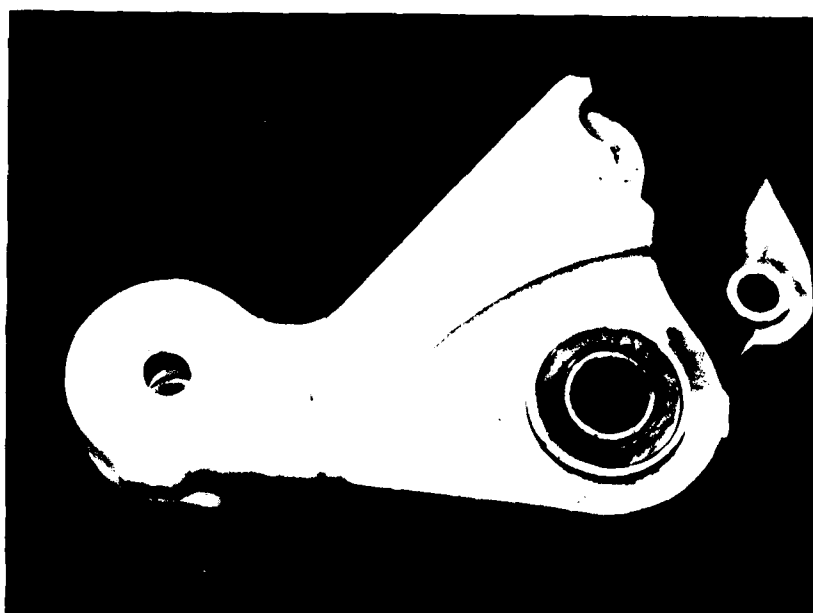
Figure 13. Failure Mode Exhibited by Lateral Differential Bellcrank Assembly, Fatigue Test Specimen Number 2 of 7149-T73 Material

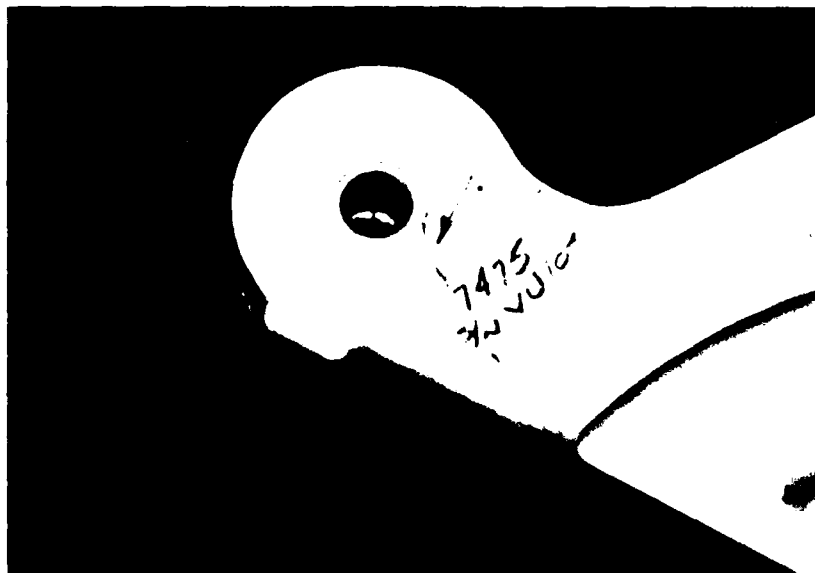
Figure 14. Failure Mode Exhibited by Lateral Differential Bellcrank Assembly, Fatigue Test Specimen Number 4 of 7475-T73 ITMT Material

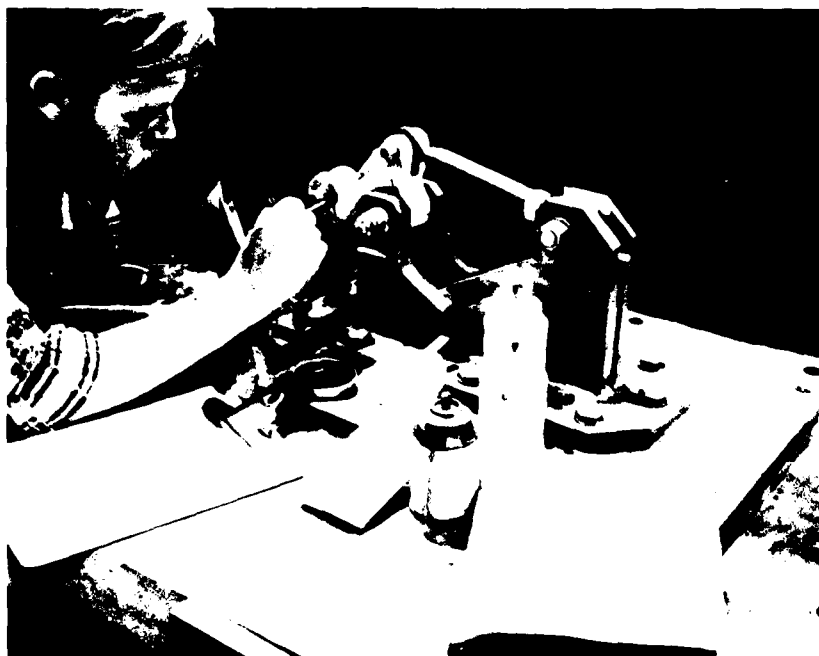
Figure 15. Test Setup for Measuring Fatigue Crack Propagation Data on Lateral Differential Bellcrank Assembly

Damage tolerance information, in the form of fatigue crack growth data, was obtained on three bellcrank assembly specimens, one of each of the three alloy/processing combinations. The crack growth data was obtained utilizing the same test fixture and setup arrangement as that used for the basic fatigue testing. The fatigue crack growth testing setup is shown in Figure 15. The fatigue cracks were monitored visually and their length and the corresponding number of loading cycles were recorded. The cracks were monitored with the aid of a strobe light while the specimen was being dynamically loaded. Dye penetrant (Type MIL-I-25135, Spotcheck SLK-HF Penetrant by Magnaflux Corporation) was used as an aid in following the cracks. The resulting data is summarized in Table 6.

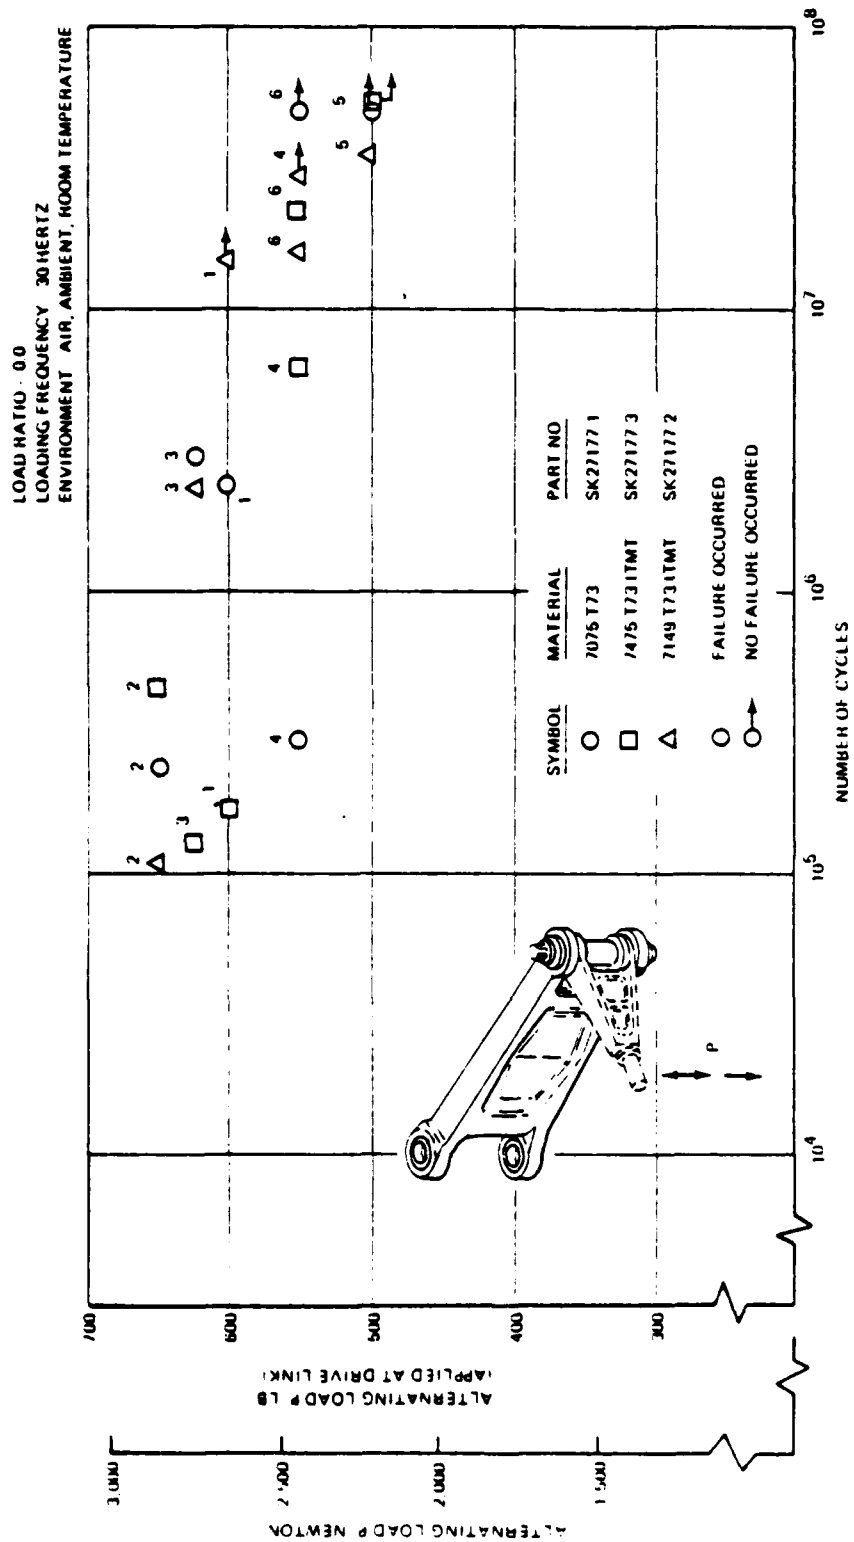
The L-N data for the drive scissors arm assembly specimens is shown in Figure 16. The number of cycles to failure was established as that point where sufficient cracking or loss of stiffness had occurred to cause the specimen deflection to exceed a preset limit value which automatically shut off the fatigue test machine. Figures 7 through 9 show typical failure modes at the point of test machine shut off. As indicated previously, the test was arranged such that at each applied test load level, three specimens, one of each alloy/processing combination, were tested. The alloys of the specimens surviving for the longest and shortest number of cycles at each load level are summarized below:

Figure 16. Plot of L-N Data for Drive Scissors Arm Assembly

A review of the above summary and the plot of Figure 16 indicates no significant differences in the fatigue strength performance of the three alloy/processing combinations based on the nominal data.

2. The fatigue strength of 7475-T73 ITMT and 7149-T73 ITMT die forgings were found to be approximately the same as those of the conventional 7075-T73 die forgings (Figures 16 and 17). It should be noted that the Phase I program coupon testing described in Reference 1 would have predicted essentially the same fatigue performance for the ITMT and conventionally processed forgings in the size range of the components which were tested. The significant increase in fatigue strength related to the ITMT processing per Reference 1 was seen with thick sections and loading in the short transverse grain direction. The components tested in this program did not possess these characteristics; however, the correlation with coupon data which was seen indicates that it is reasonable to expect ITMT processed die forging to exhibit improved fatigue strength for thick forgings with critical stresses in the short transverse grain direction.

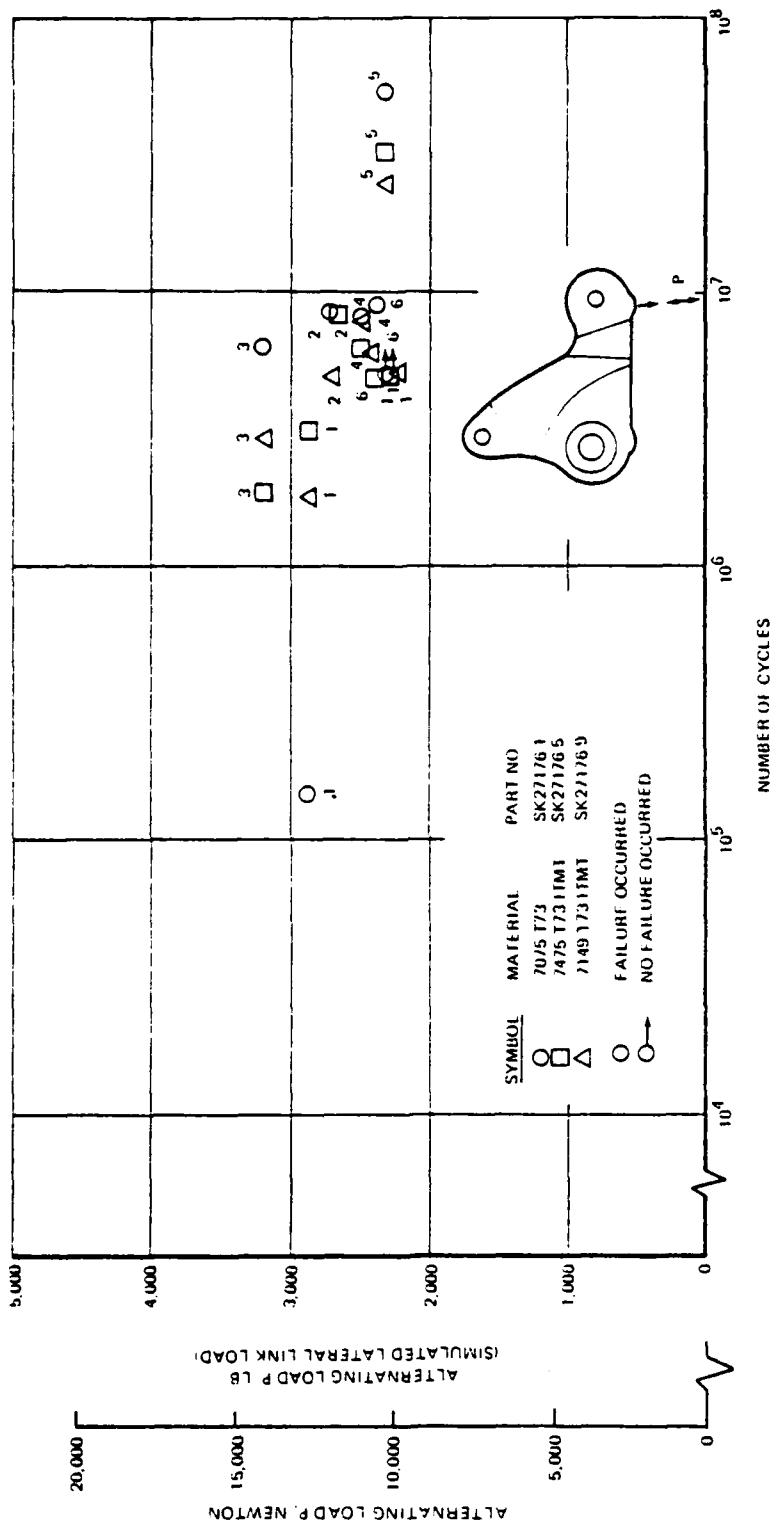
The L-N data for the lateral differential bellcrank assembly specimens is shown in Figure 17. The number of cycles to failure was established as that point at which cracking was first observed. Failures in these specimens occurred at lugs and the possibility for load sharing between the two lugs of the pair made it impractical to use deflection as a criterion for failure. Figures 11 through 14 show typical failure modes at the point of test completion. As described previously, a summary of the alloys of the specimens surviving for the longest and shortest number of cycles at each load level is shown below.

Figure 17. Plot of L-N Data for Lateral Differential Bellcrank Assembly

For the lateral differential bellcrank assembly specimens, the predominant failure location was one of the lugs of lug pair A as indicated in Table 5. Figure 19 shows a plot of L-N data for the lug pair A location only. The differences between the plots of Figures 19 and 17 are minor and the initial conclusions hold.

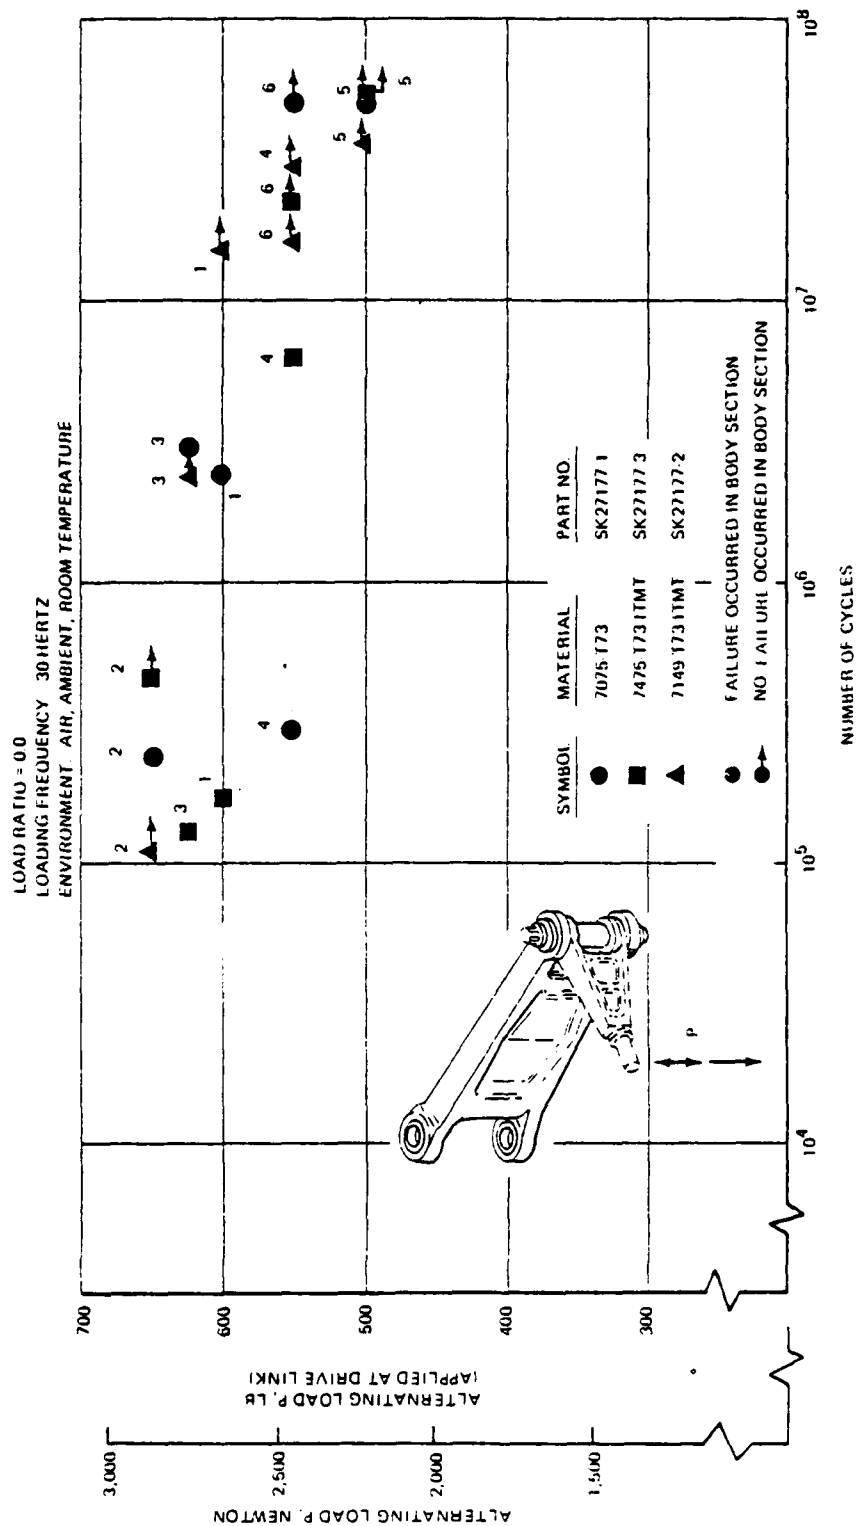
In the case of the drive scissors arm assembly, a review of Table 4 indicates that somewhat more than one half the failures occurred in the basic body section of the arm as opposed to the lugs. Figure 18 shows a plot of L-N data for the body section only. In this case, it is seen that no body section failures occurred in specimens of the 7149-T73 ITMT material. The specimens of the 7475-T73 ITMT and 7075-T73 materials show almost the same average fatigue strength with respect to failures in the body section. The fatigue origins associated with the body section failures occurred at varied locations, such as section transitions, adjacent to tooling pads, or associated with part marking. Failures originating in the lug areas occurred only on the specimens of the 7149-T73 ITMT and 7475-T73 ITMT materials. Lug failures occurred most frequently in specimens of the 7149-T73 ITMT material.

Figure 18. Plot of L-N Data for Drive Scissors Arm Assembly Body Section

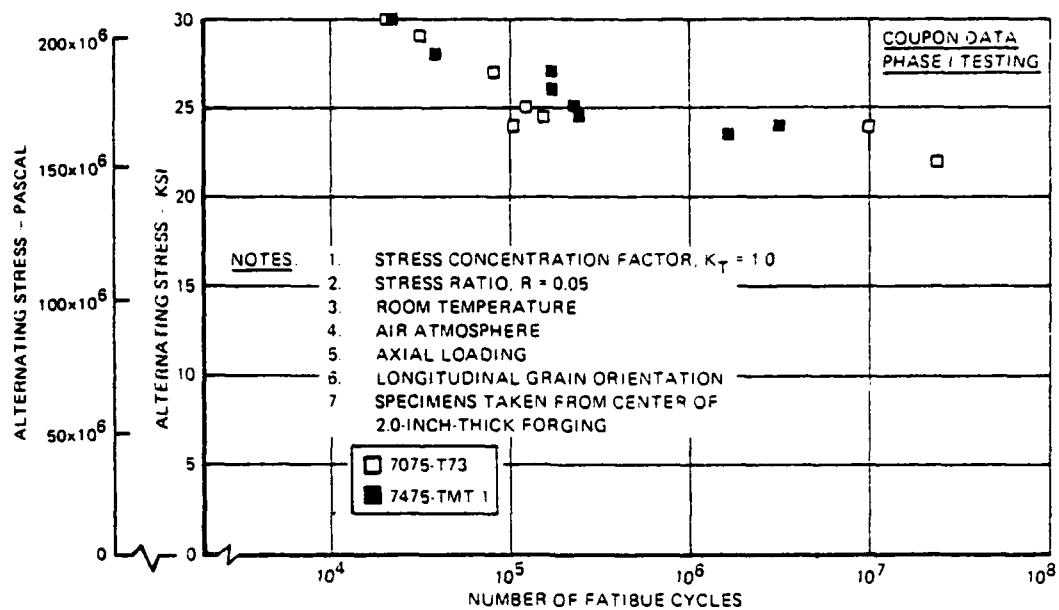
Figure 20. Comparison of Fatigue Strengths for 7075-T73 and 7475-TMT1 Forgings, Groups 3 and 10 (From Reference 1).

Figures 20 through 23 provide a general comparison of the relative fatigue performance of the 7075-T73 and 7475-T73 ITMT materials as coupon and as component specimens. Figures 20 and 21 were selected from Reference 1 as being the most applicable coupon fatigue data for comparison with the component data. The 7475-TMT 1 material cited in Figures 20 and 21 was determined to be optimally processed and that process was selected for the drive scissors arm and bellcrank component forgings of the 7475 and 7149 alloys. The coupon data is associated with a two-inch thick forging, roughly the size of the components which were tested. The coupon data is for stress concentration factors of 1.0 and 3.0. The stress concentrations associated with the components range from about 1.5 to somewhat greater than 3.0 depending on the particular failure location. In the case of the bellcrank failures which were associated with fretting, there is no direct comparison which can be made with the coupon data. The similarity of stress ratios for coupon and component data is quite close for the drive scissors arm assembly specimens (+0.05 vs 0.0) but only roughly comparable for the bellcrank specimens. In Figures 22 and 23, the component data are identical to Figures 16 and 17 respectively, except that the 7149 data has been removed and symbol changes have been made so that comparisons may be made with greater ease. Comparisons based on the relative fatigue strengths of the two alloy/processing combinations do not appear significantly different between coupons and components. The fact that the relative

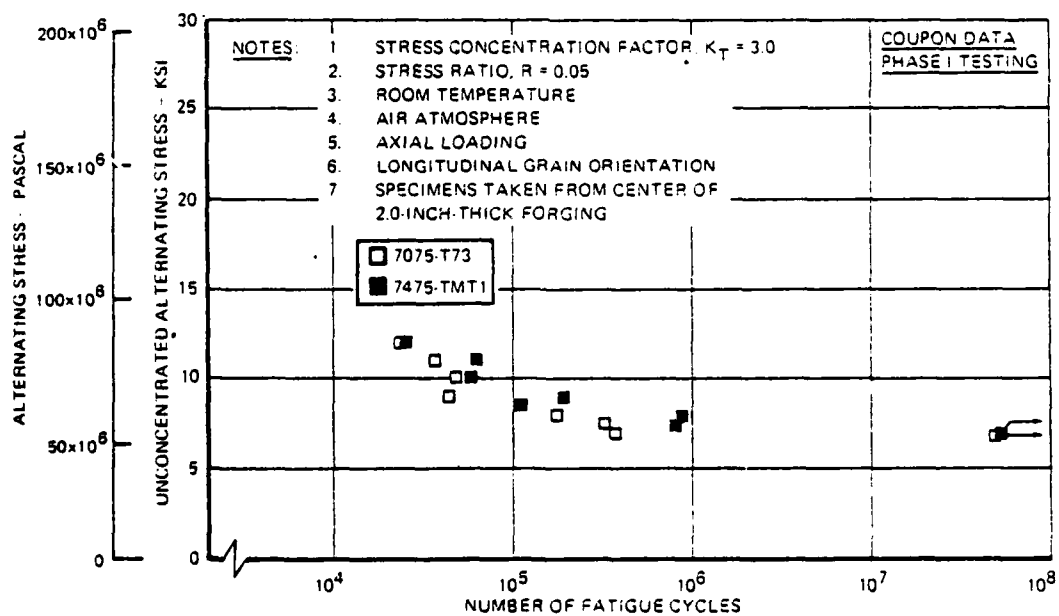
Figure 21 Comparison of Fatigue Strengths for 7075-T73 and 7475-TMT1 Forgings, Groups 4 and 13 (From Reference 1).

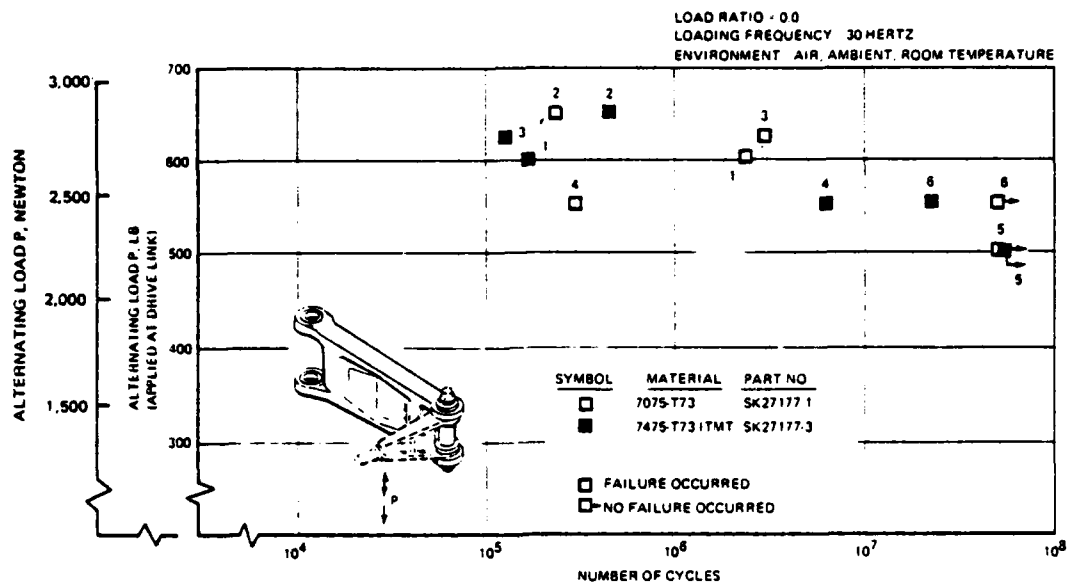
Figure 22. Plot of L-N Data for Drive Scissors Arm Assembly Specimens of 7075-T73 and 7475-T73 ITMT Materials

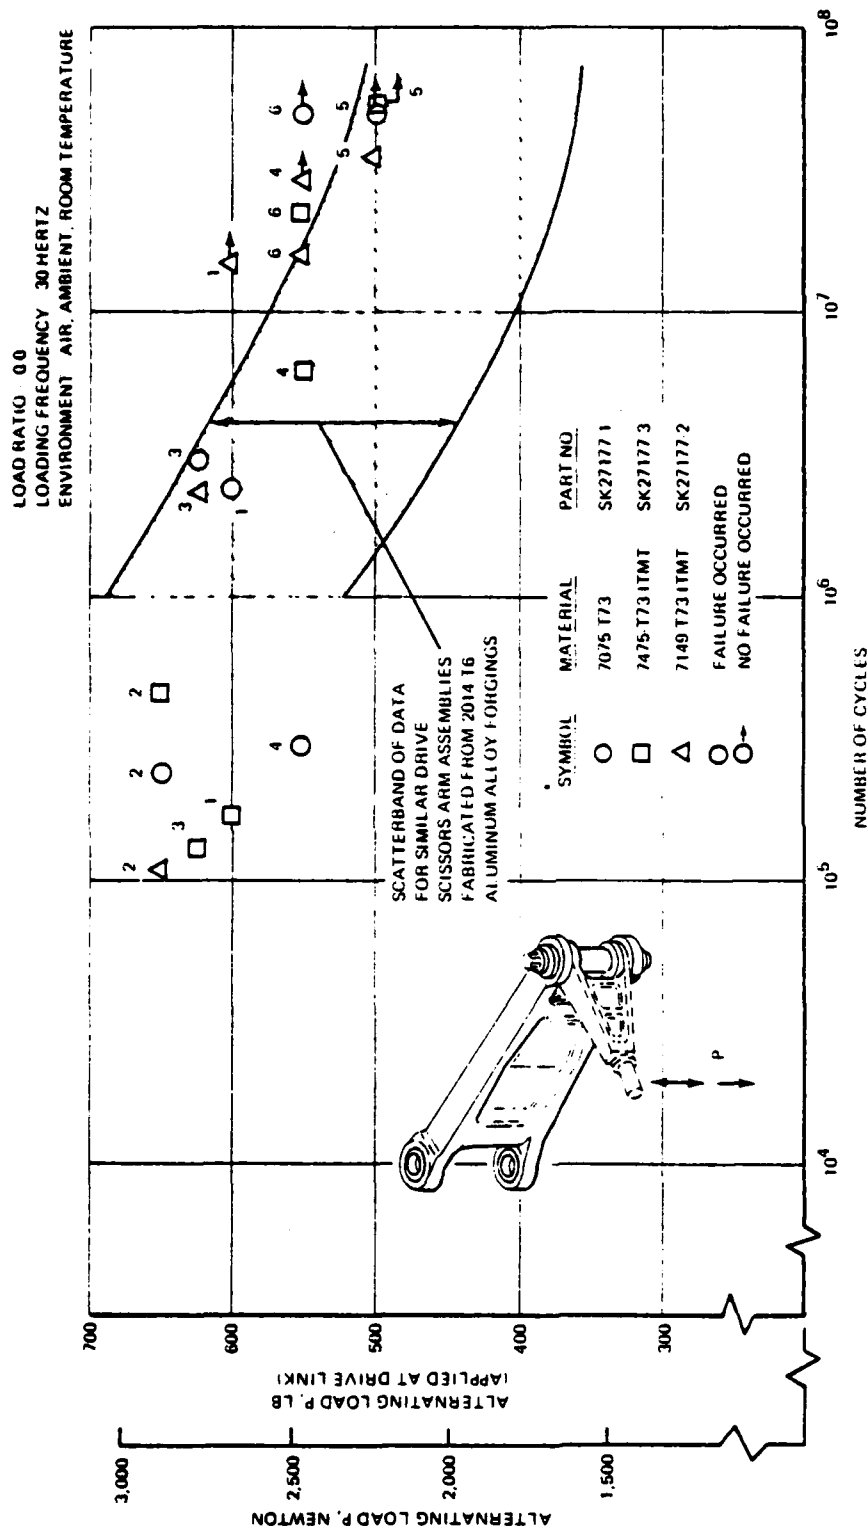
Figure 24 presents a comparison of fatigue strength performance for the drive scissors arm assembly. The data points obtained in this program from the 7XXX-Series aluminum alloy specimens are shown. Also shown is the scatter band of data from previously tested drive scissors arm assembly specimens fabricated from 2014-T6 aluminum alloy forgings. The scatter band shown was based on tests of six specimens and was developed from the data contained in References 2 and 3. The comparison is presented to show data trends only and is not valid for making a rigorous direct comparison because of certain differences in design details. The specimens fabricated from the 2014-T6 material had certain features which acted as stress risers and were deleted from the specimens fabricated from the 7XXX-Series alloys. However, within the data scatter band of the 2014-T6 specimens, a number of different failure modes were exhibited, just as was the case with the 7XXX-Series alloy specimens. In some instances, the failure modes and local geometry of certain specimens within the two groups (2014-T6 and 7XXX-Series) are identical, thereby make possible a valid comparison for those limited number of specimens.

Figure 24. Comparison of Drive Scissors Arm Assembly Fatigue Test  
Data: 7XXX-Series Alloy Specimens Tested in Current  
Program Versus 2014 Alloy Specimens Tested in a Previous  
Program

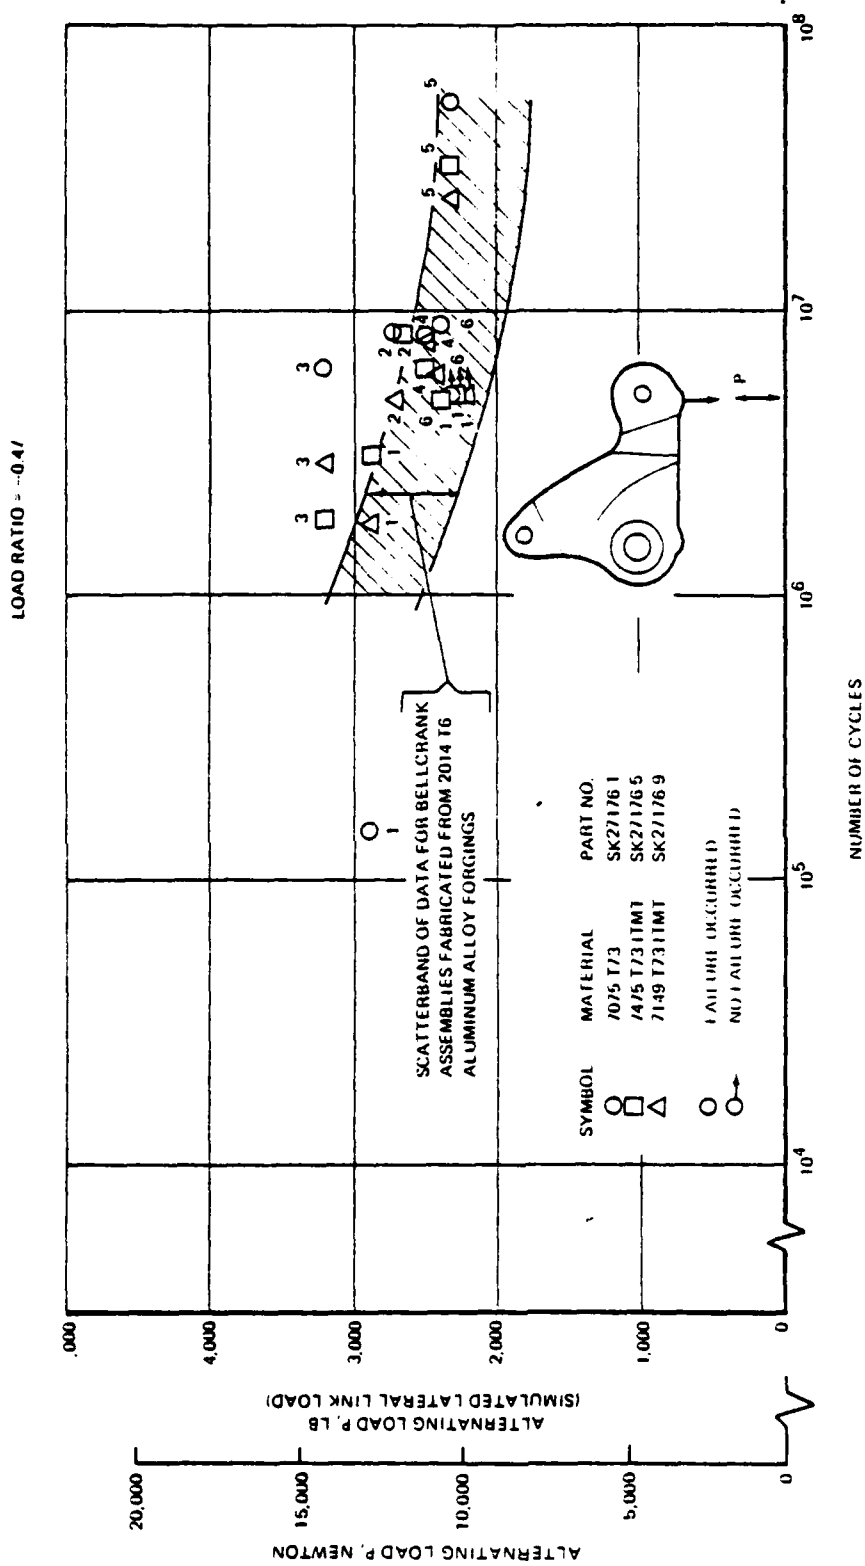
Figure 25 presents a comparison of fatigue strength performance for the lateral differential bellcrank assembly. The data points obtained in this program from the 7XXX-Series alloy specimens are shown. Also shown is the scatter band of data from previously tested bellcrank assembly specimens fabricated from 2014-T6 aluminum alloy forgings. The scatter band shown was based on tests of six specimens and was developed from the data contained in Reference 2. A direct valid comparison between the two groups of data can be made since specimen geometry was the same. The 7XXX-Series alloy specimens exhibit a higher average fatigue strength than the 2014-T6 specimens. In the case of the 7XXX-Series alloys specimens, the predominate failure location was lug pair "A" as identified in Table 5. In the case of the 2014-T6 specimens, the predominate failure location was lug pair "B".

Figure 25. Comparison of Lateral Differential Bellcrank Assembly Fatigue Test Data: 7XXX-Series Alloy Specimens Tested in Current Program Versus 2014 Alloy Specimens Tested in a Previous Program
